DEPARTMENT OF TRANSPORTATION

Quality Assurance and Source Inspection

Contract #: 04-0120F4Cty: SF/ALA Rte: 80 PM: 13.2/13.9File #: 69.28**WELDING INSPECTION REPORT****Resident Engineer:**Siegenthaler, Peter**Address:** 333 Burma Road**City:** Oakland, CA 94607**Report No:** WIR-024858**Date Inspected:** 19-Jun-2011**Project Name:** SAS Superstructure**OSM Arrival Time:** 700**Prime Contractor:** American Bridge/Fluor Enterprises, a JV**OSM Departure Time:** 1900**Contractor:** Zhenhua Port Machinery Company, Ltd (ZPMC), Changxing Island **Location:** Shanghai,China**CWI Name:** Liu Hua Jie/Lv Li Qing**CWI Present:** Yes No**Inspected CWI report:** Yes No N/A**Rod Oven in Use:** Yes No N/A**Electrode to specification:** Yes No N/A**Weld Procedures Followed:** Yes No N/A**Qualified Welders:** Yes No N/A**Verified Joint Fit-up:** Yes No N/A**Approved Drawings:** Yes No N/A**Approved WPS:** Yes No N/A**Delayed / Cancelled:** Yes No N/A**Bridge No:** 34-0006**Component:** OBG**Summary of Items Observed:**

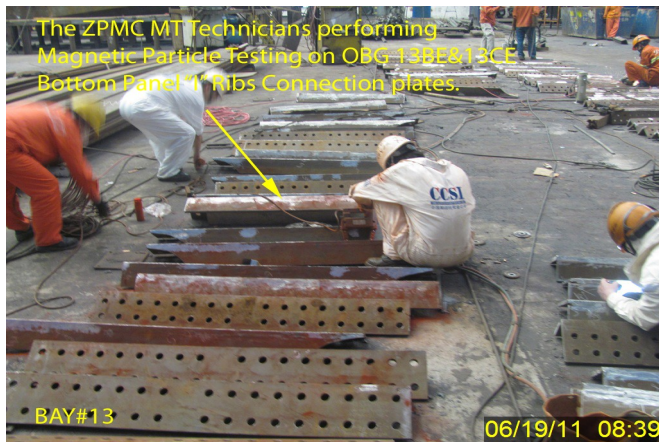
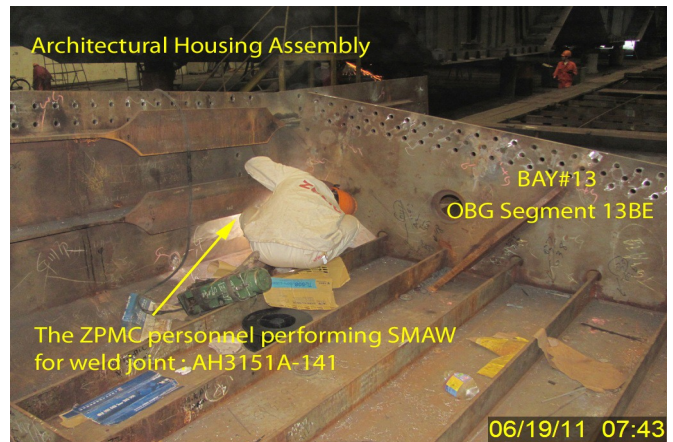
SMAW in the 4G position for the OBG Segment 13BE Architectural Housing Assembly. The weld joint was designated as: AH3151A-141. The welder is identified as #051359. ZPMC CWI is identified as Mr. Lv Li Qing. The welding variables recorded by QC appear to comply with WPS-B-P-2214-B-U2-FCM-1. Please see the attached picture.
